MATERIALS FOR ADVANCED TURBINE ENGINES

Project Completion Report Project 3

ADVANCED BLADE TIP SEAL SYSTEM Volume II

GENERAL ELECTRIC COMPANY
AIRCRAFT ENGINE BUSINESS GROUP
ADVANCED TECHNOLOGY OPERATIONS
CINCINNATI, OHIO 45215

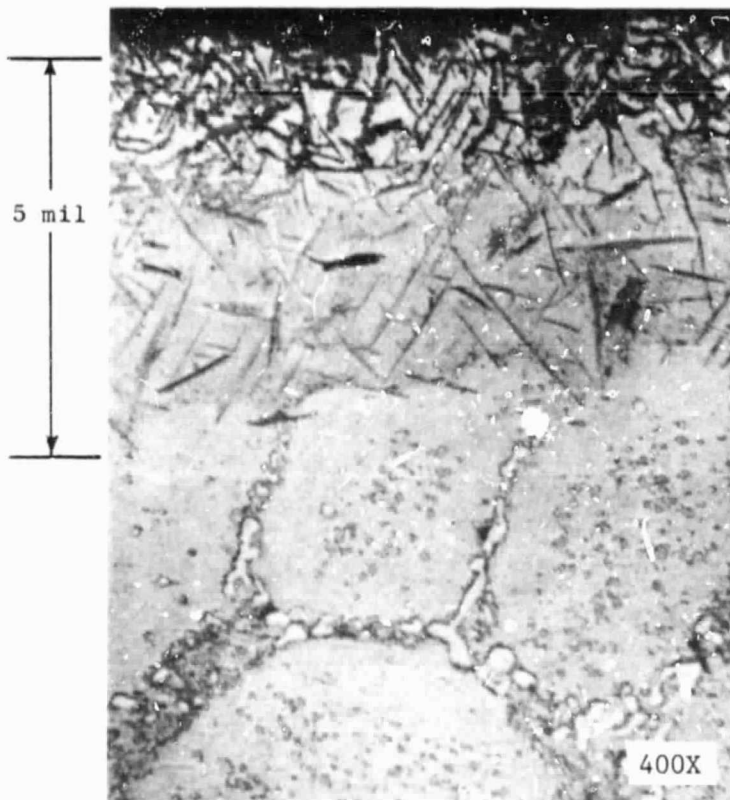
All exposed (uncoated or cracked) surfaces of the monocrystal Normalloy material exhibited internal oxidation ranging from moderate to high (as shown in Figures 3 and 4). Oxide penetration in the cracks was severe, suggesting that the cracks had initiated relatively early in the engine test, probably as the result of thermal fatigue. The cracks appeared to be low cycle fatigue in mode and initiated in the oxidized layer of the monocrystal and extended down through the bond joint and into the René 80 blade material as shown in Figure 5. The balance of the monocrystal material exhibited a complete "twinning" type of recrystallization (Figure 6), which conceivably could have been caused by the severe rub encountered during the early portion of the engine test. In all cases, the monocrystal-to-blade ADB joint was intact with no distress noted. The dent (FOD of unknown origin) on the one blade, shown in Figures 7 and 8, was confined to only the monocrystal material where conventional recrystallization was evidenced; again, "no" distress was found in the ADB joint.

Figure 3. Monocrystal Normalloy Tip After
Endurance Testing Showing
Oxidized Layer.

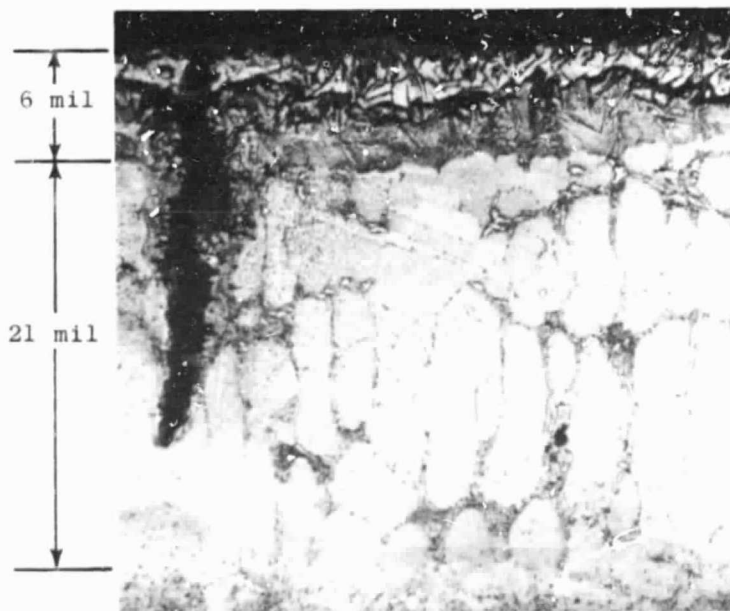
Figure 4. Radial Crack in Monocrystal Normalloy
Tip After Endurance Testing.

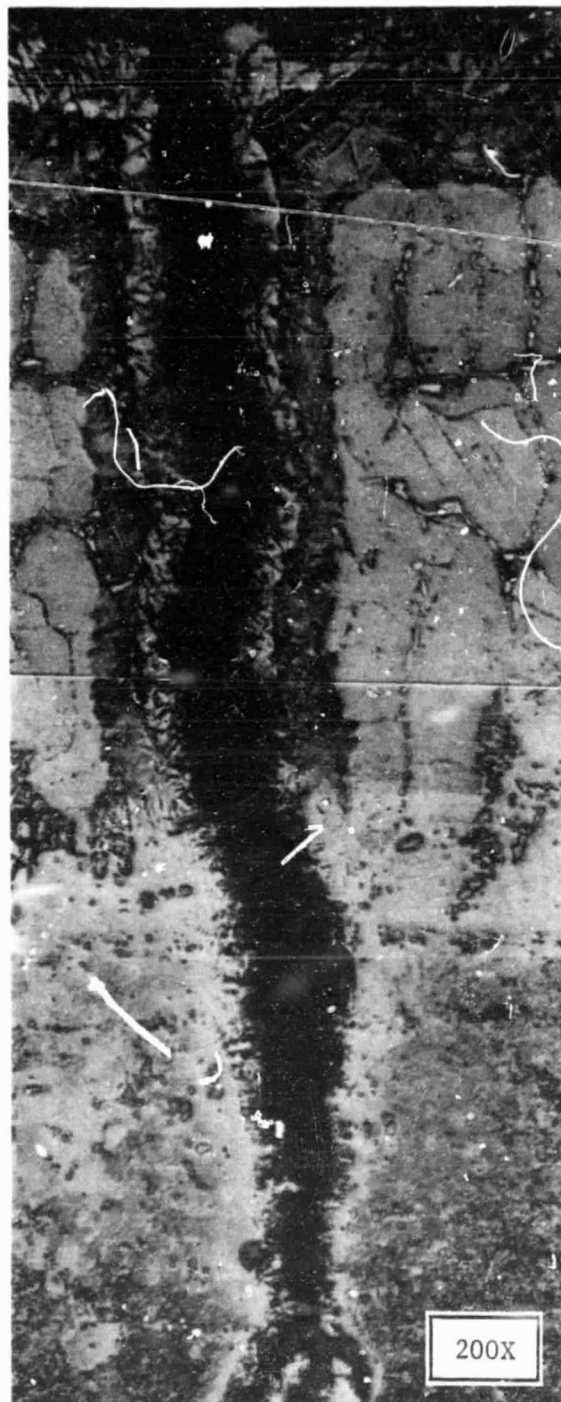
Figure 5. Crack in Monocrystal
Normalloy Blade Tip
After Endurance Testing.
The Crack Extended
Through the ADB Joint
and Into the René 80.

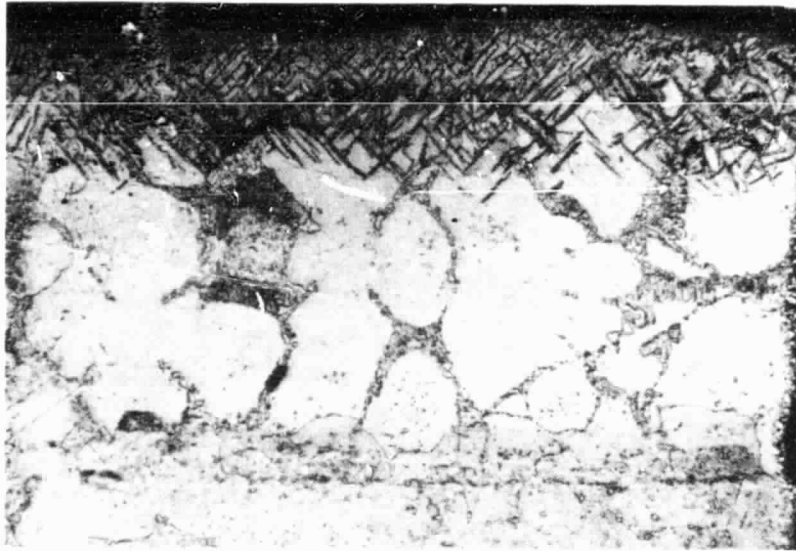
Figure 6. Monocrystal Normalloy Tip Material
After Endurance Testing Showing
Recrystallization.

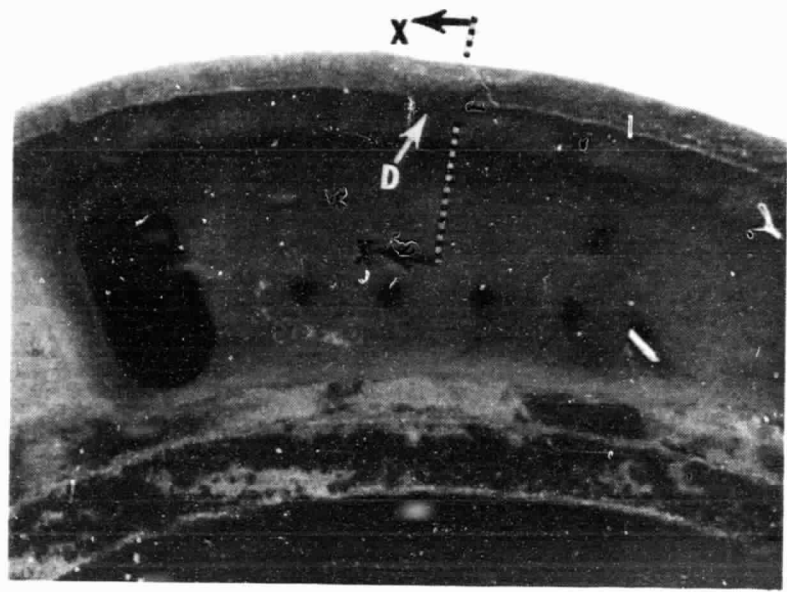
Five of the 20 monocrystal-tipped turbine blades from Engine 415-508/21 were submitted for metallurgical evaluation. Four of the blades had radial tip cracks; the fifth blade exhibited a dent (FOD) on the convex side of the blade at midchord. The purpose of this evaluation was to assess the condition of the monocrystal tip material and the bond joint and to determine the origin and cause of the radial cracking that had occurred in the monocrystal material.

Figure 7. Dent (FOD) in Blade Tip After
Endurance Testing.

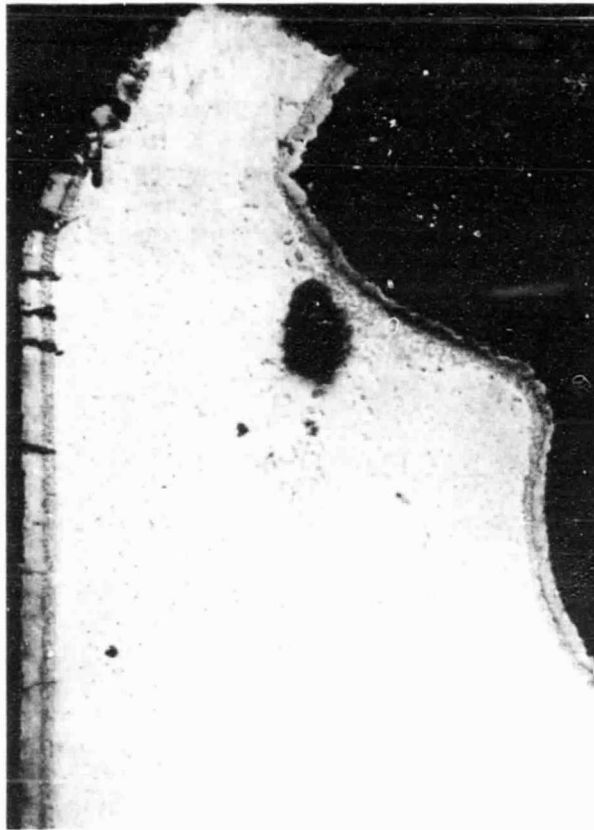
Figure 8. Cross Section of Dent in
Monocrystal Normalloy
Blade Tip.

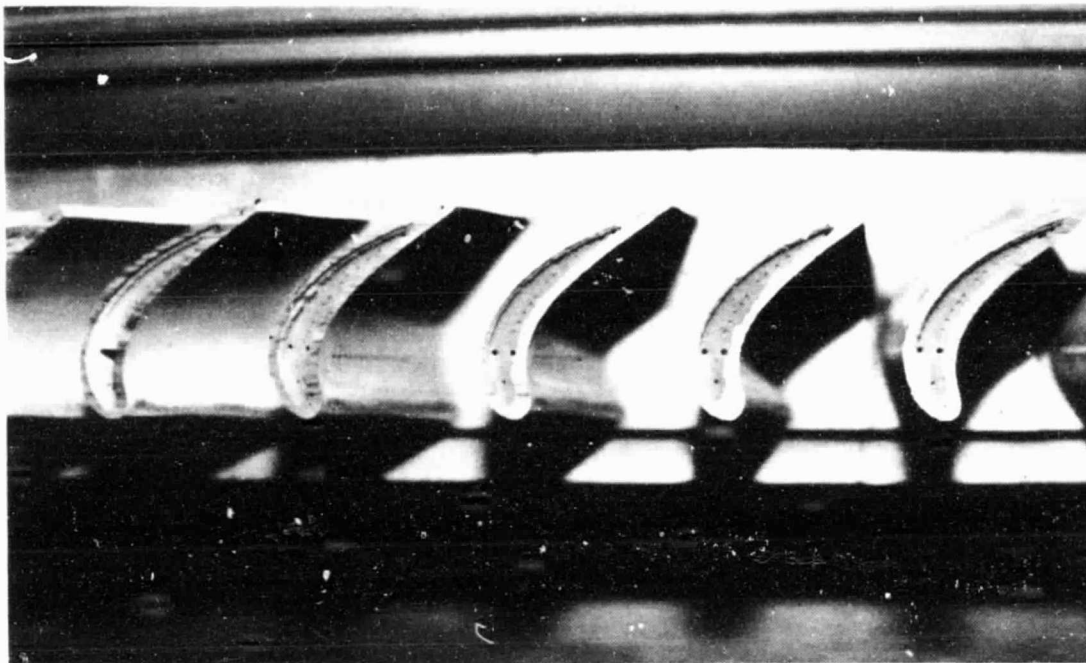
The rotor assembly (blades) and shroud assembly after engine testing are shown in Figures 9 and 10. As shown in Figure 10, considerable rub ($\sim 180^\circ$) had occurred, the heaviest of which occurred on six shrouds between the 1:00 and 4:00 positions ($\sim 90^\circ$). The shrouds were removed from the shroud assembly and measurements were made to determine the extent of shroud removal. The volume of material removed was substantial. The greatest depth of shroud rub was at a position corresponding to the midchord of the blade where up to 0.46 mm (0.018 inch) of shroud had been removed as shown in Figure 11. Lesser, but still significant (0.30 mm [0.012 inch]), amounts of shroud material were removed at regions corresponding to the ends of the tip cap cavity. The very trailing edge of the tip did not remove any shroud material which was believed to be the result of the higher temperatures present in this uncooled region of the blade tip. A distribution of grind capability versus axial position along the blade tip is shown in Figure 12.

Figure 9. Stage 1 HPT Blades with the Advanced Tip System After Performance Engine Testing.

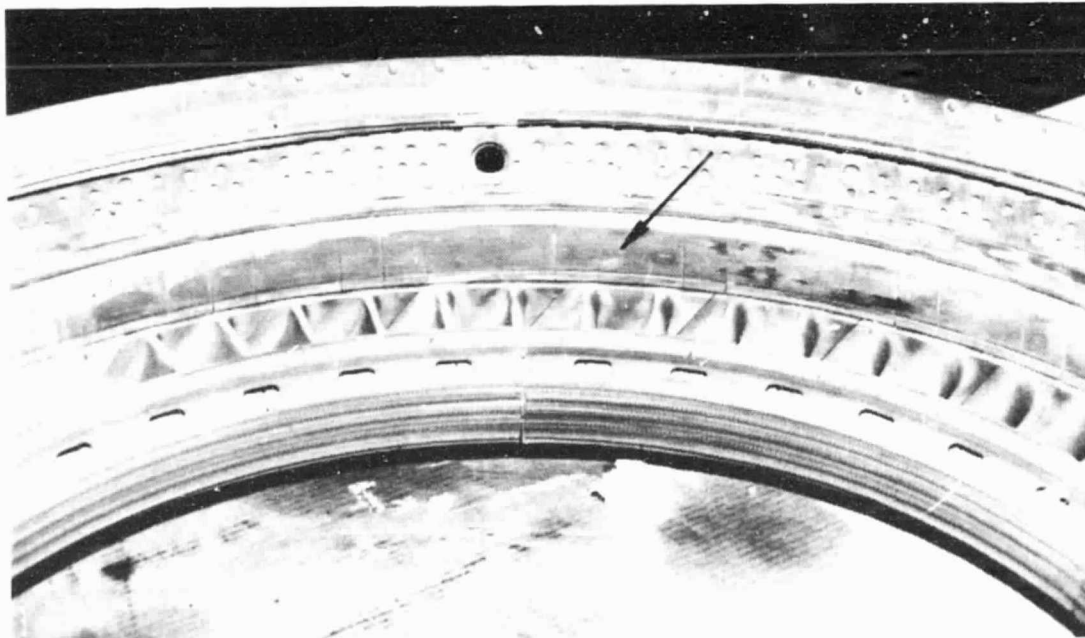
Figure 10. CoNiCrAlY Shrouds After Performance Engine Testing.

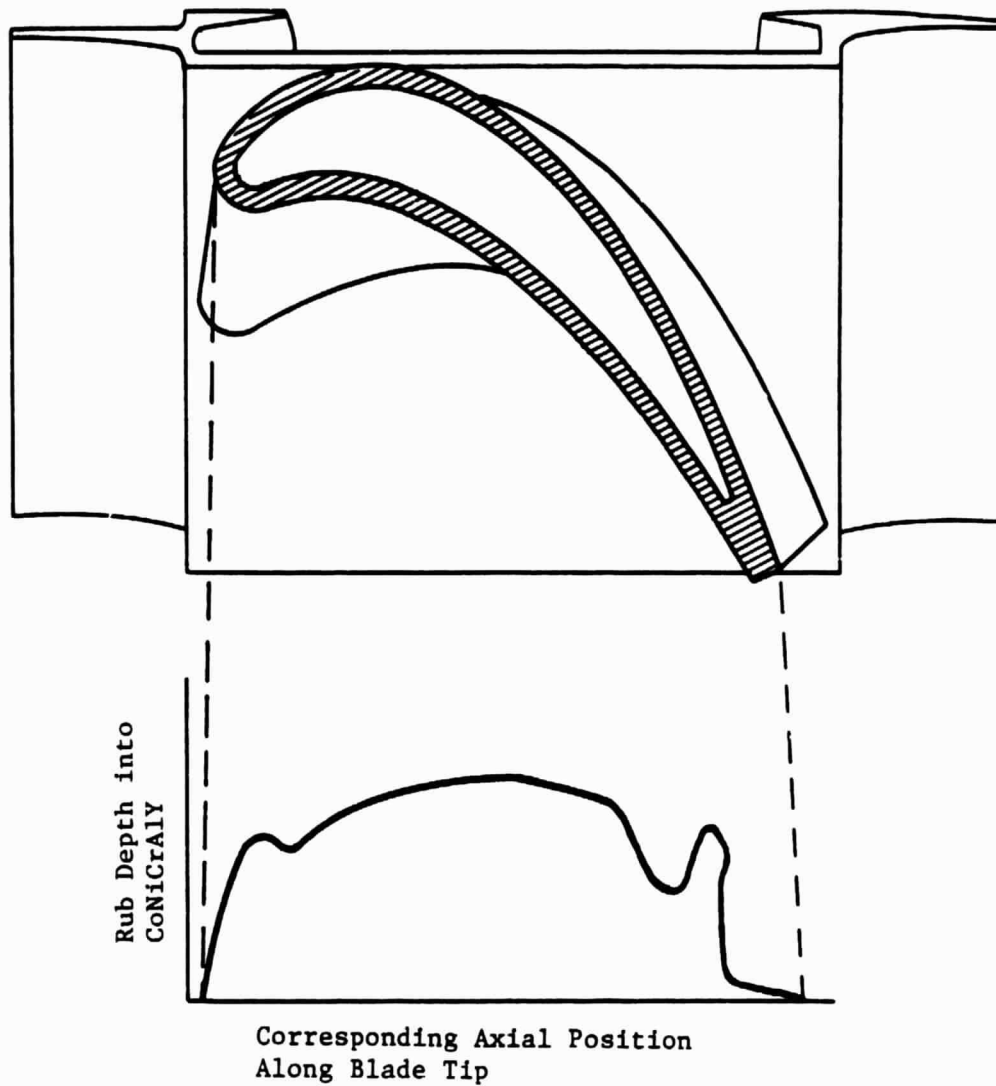
Figure 12. CoNiCrAlY Shroud Removal Versus Axial Position Along Tip After Engine Test.

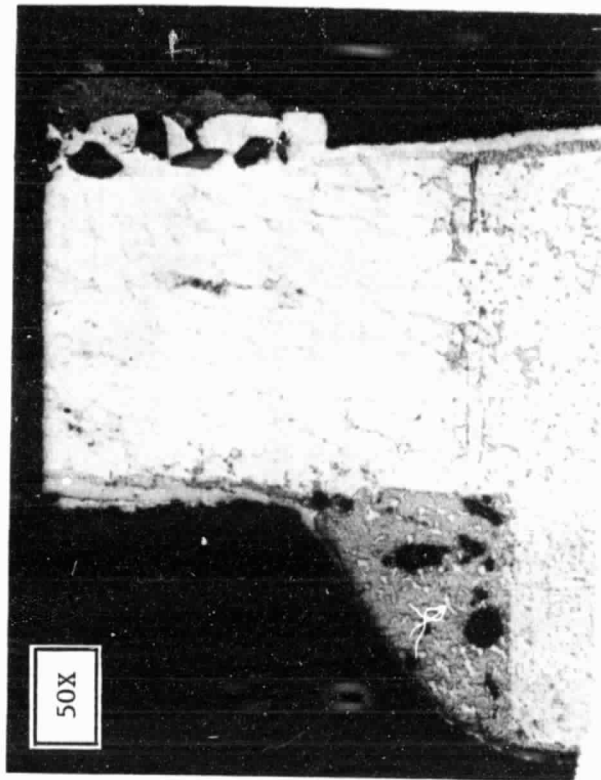
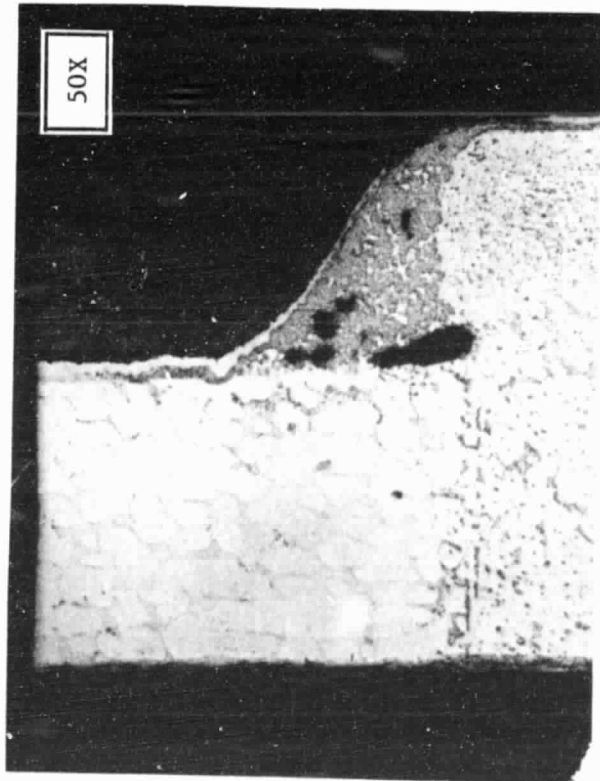
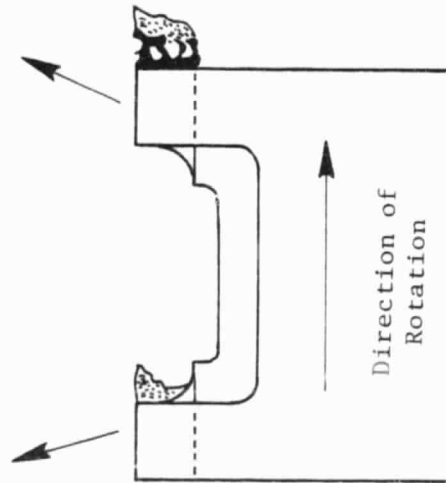
Selected blade tips and shrouds were sectioned and evaluated. Figure 14 shows a cross section of one of the blades at approximately midchord. As shown in this figure, both the monocrystal material and the ADB joint were intact. Also shown is the debris that had collected on the suction sides of the squealer tips. This debris has been identified as CoNiCrAlY and was shown to be on all of the blade tips. Note also that the abrasive treatment is

Figure 14. Cross Section of Advanced Blade Tip System After Endurance Engine Testing.

still present on the suction side of the airfoil. The condition shown in Figure 14 was typical of all of the sections evaluated.
